BUILDING REPORTS N.S.W.

Building Report

Complies with Australian Standard AS 4349.1-2007

55 Sample St Willoughby

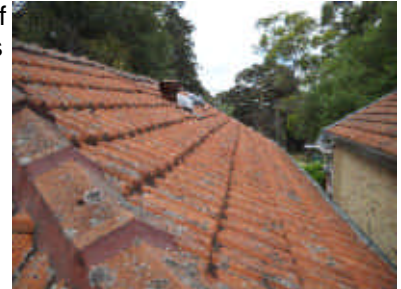
Roof Covering Condition Detail: The overall condition of the roof coverings is fair. Roof area should be cleaned to remove, lichen and or moss buildup. Some repair & maintenance of the roofing material may be required following clean. A roofing expert should further evaluate the roof area. Visible deflection was noted to the roofline. For more detail see section under "Roof System Internal".

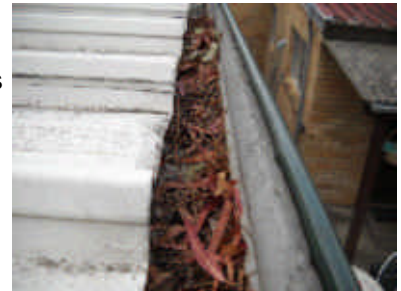
Gutter & Downpipes Condition: Appear to be in serviceable condition. Leaves and debris are present in gutters and the guttering should be cleared. The design and position of the guttering is such that during wet conditions it appears that the gutter may back flow into the eave or building. Recommend the area be evaluated during wet conditions. Some modifications may be required.

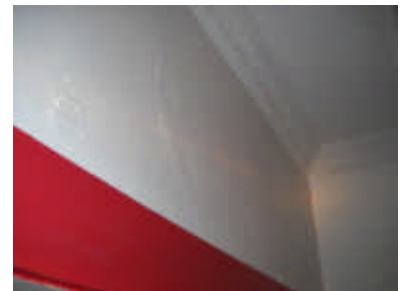
Location/Area: Main bedroom: Bedroom two: Hallway: Toilet.

The condition of the walls is generally fair. Defective or poor surfaces were noted to some sections of the wall materials and repairs are required prior to next repainting. Settlement cracks are evident to wall areas. Maintenance and repairs are required prior to next repainting. Please refer to section of this report - CRACKING OF BUILDING ELEMENTS for additional details.

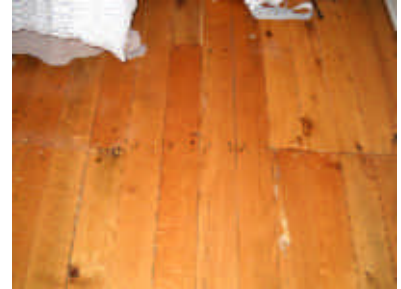
Location/Area: Main bedroom: Bedroom two: Bedroom three:

Floors Condition: The condition of the floors is generally fair. Evidence of what appears to be timber pest attack was noted. Please refer to pest inspection report for details.

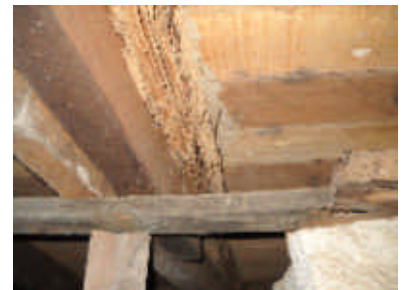
Location Or Area: Bedroom two: Bedroom three:

- Description:** Evidence of what appears to be timber pest attack was noted. Please refer to pest inspection report for details.
- Affected Subfloor Timbers:** Floor joist/s:

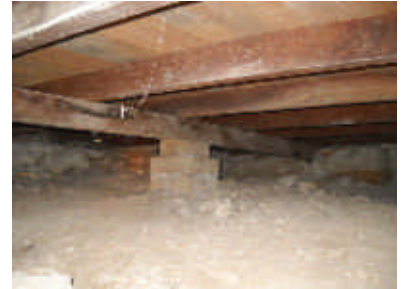
Location Or Area: Bedroom three:

Description: Minor wood decay damage was noted. Maintenance and repair is required.

Timbers: Bearers:

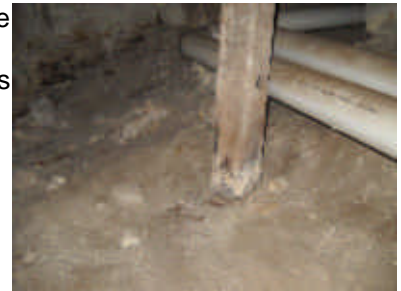
Timber floor supports are located to the sub floor of the building. This practice is conducive to timber pest attack and supports should be replaced with brick piers or steel supports. We recommend the removal of loose timbers from the underfloor area as these predispose the property to timber pest attack.

Some areas do not have ant capping. Ant capping is installed to deter termites forcing them to build their mud tubs around the ant capping enabling detection during inspection. Recommend a sub floor access

door be installed to prevent vermin entry and secure the area. Cabling to the sub floor area is loose and should be secured to the underside of the floor to prevent accidental dislodgement.

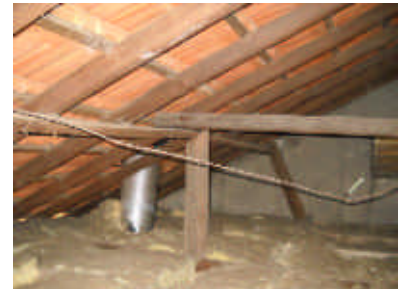
Location/Area: Throughout:
Licence class recommended to evaluate further; Carpentry.

Cut and pitched roof. Additional support and or rectification is required in the form of; Struts: Purlins are not sufficiently supported by correctly placed or sufficient number of struts. A strutting beam must be correctly placed over load bearing walls.

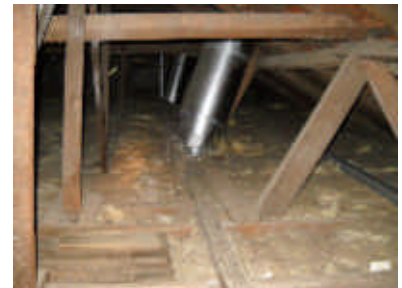
Insulation Status: Insulation has been provided to the roof void.

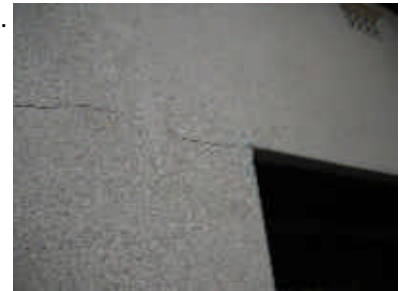
Defect Cracking: Located; West elevation Width 0.5-1mm, Length 2.0M.

Due to the unpredictable nature of cracking in building elements it is not possible for the inspector to determine past or future occurrences that have or will impact cracking in this building. Because of these unknown factors and the possibility of concealed defects related to cracking in building elements we recommend an engineer be consulted prior to acceptance or purchase of this building.
