Building and Pest Report

Complies with Australian Standard AS 4349.1-2007

88 Sample Rd Alexandria

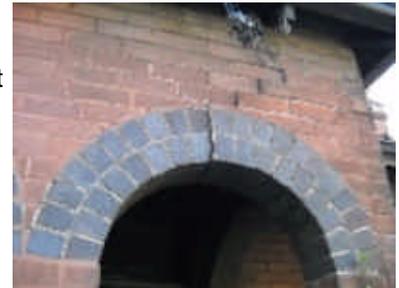
Wall Condition: The condition of the walls is generally poor. Cracks are evident to masonry walls including the front entry veranda area. There appears to have been significant settlement to the front of the house. Brickwork is damaged and will require repairs and or replacement. Visible cracking appears major and a Structural Engineers opinion should be sought. Please refer to section of this report - CRACKING OF BUILDING ELEMENTS for additional details. These external walls appear to be of solid masonry construction without the presence of a cavity to prevent lateral moisture transfer. This may allow internal wall areas to become moist and recommend the external wall areas be sealed or a cavity with appropriate damp coursing/flashings be installed. Mortar joints between brickwork are deteriorating and require re pointing in areas.

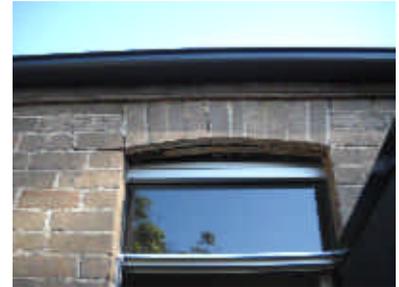
Lintel type/s noted: Mild steel: The condition of the lintels is generally poor. Severe rust is evident to the steel lintels. Damaged lintels should be replaced. Cracks have formed adjacent to rusted lintels and damaged wall areas will require maintenance and repair.

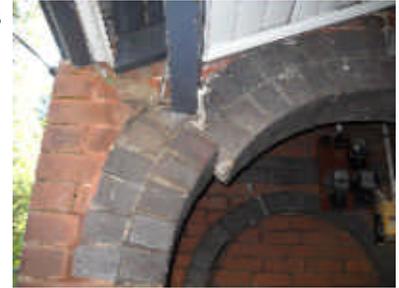
Cracking and settlement is noted to the floor and walls in this area. Damaged areas require repair or replacement.

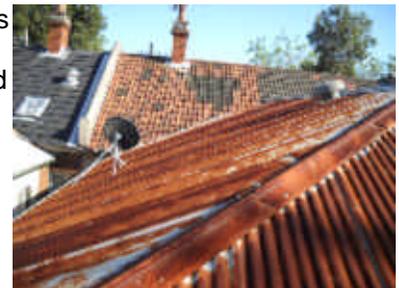
The overall condition of the concrete tile roof coverings is fair. The overall condition of the corrugated steel roof coverings is poor. The metal roofing is rusted and requires treatment to prevent further deterioration.

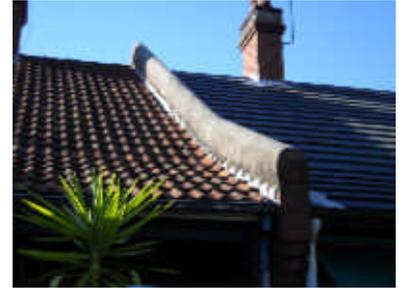
Flashing material is of lead. Flashings appear to be in serviceable condition. Flashing is not or does not appear to be correctly set into the brickwork. This can allow water penetration and should be rectified. Flashing and or sealing is required to the roof parapet walls to prevent water entry.

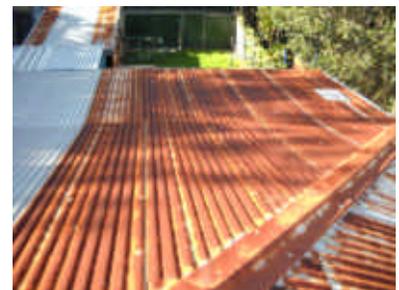
Condition Detail: The overall condition of the roof coverings is poor. The metal roofing is rusted and damaged areas require replacement.

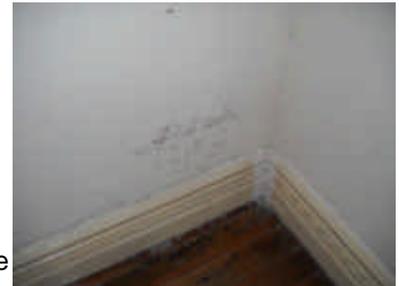
Location/Area: Main bedroom: Bedroom two: Bedroom three: Lounge room: Hallway:

The condition of the walls is generally poor. Rising damp is evident to the base of some or all masonry walls. Damp proof coursing material may have been bridged or should be replaced. Quotations should be obtained from a suitably qualified contractor to rectify damp areas. Cost to replace damp proof coursing material can range upwards from \$250.00 per linear metre excluding re-instatement of wall finishes. Settlement cracks are evident to wall areas some have been patched. Maintenance and repairs are required prior to next repainting. Please refer to section of this report - CRACKING OF BUILDING ELEMENTS for additional details. Evidence of lateral damp was noted due to solid brick walls including bedroom 3.

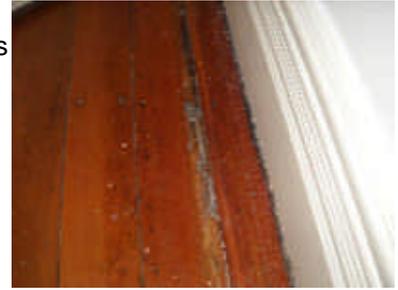
Location/Area: Throughout:

Floors Condition: The condition of the floors is generally poor. Rust stains around the nail heads indicates damp conditions in the subfloor over a long period of time. Excessive movement was noted to timber floors including front bedroom. Additional support is required to the flooring members to remove excessive movement. Evidence of what appears to be timber pest attack was noted in hallway. Damaged boards should be replaced. Please refer to pest inspection report for details.

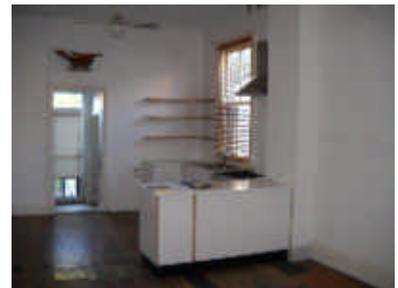
Kitchen Fixtures: Existing kitchen appears temporary. Recommend kitchen cupboards be upgraded.

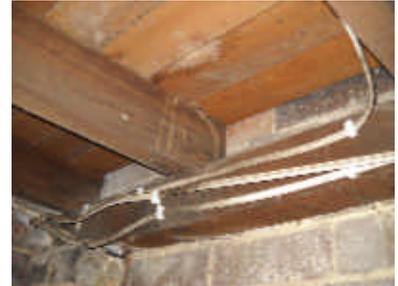
Timbers: Bearers: Floor joist/s: Flooring timbers: Minor damage to timbers at entrance area.

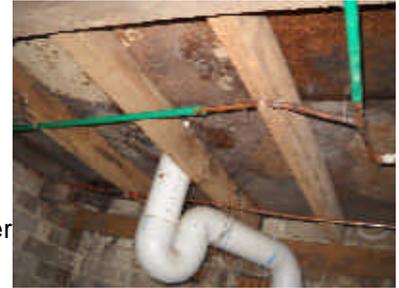
Details: The underfloor soil is damp. This may be due to a drainage problem or some other factor. This area should be monitored to determine a cause for the dampness and the problem rectified. Ant capping is not installed. Ant capping is installed to deter termites forcing them to build their mud tubs around the ant capping enabling detection during inspection. The shower recess is leaking and will require sealing. Refer to Bathroom and or Ensuite areas for details.

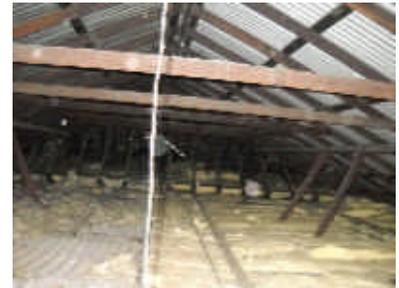
Details: A party wall is not present in the roof void between adjoining properties. This area may currently be a potential fire and or security risk. Recommend a party wall be installed.

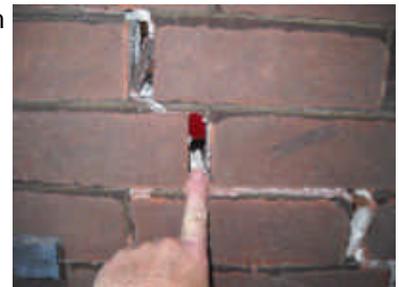
Cracking: Located; North elevation front entry area Width; 20mm Length; Various. Underpinning and reconstruction of the brick work is required.
