## Pest Report

77 Sample St Willoughby

# VISUAL INSPECTION REPORT

**Date Of Inspection:** 20th October 2010.

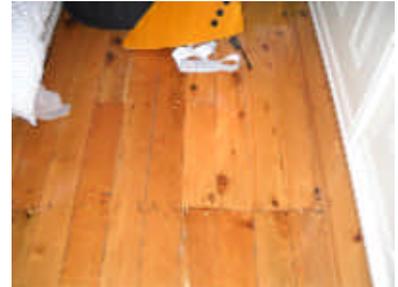
Some timbers (listed below) appear to be new or not the original timbers. This replacement may have been due to timber pest attack or some other factor. We recommend if you are using this report to purchase this property, further enquiries should be made to determine the reason for timber replacement.

Flooring timbers:

**Location/Area.** Various areas:

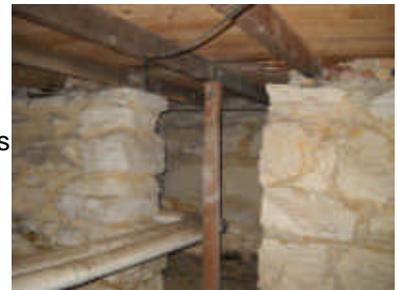
We note the general lack of ant capping or deficiencies in the fitment of ant capping. The purpose of ant capping is to reduce the risk of concealed termite attack. Ant capping should be repaired or installed where possible.

Timber supports are present in the subfloor area. These should be replaced with a non timber alternative.

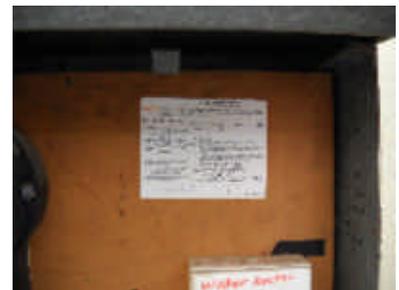
A notice indicates that the property may have been treated during construction in respect to protection against subterranean termite attack. We strongly recommend any prospective purchaser attempt to verify this information and obtain copies of all relevant documentation.
