Building and Pest Report

Complies with Australian Standard AS 4349.1-2007

88 Sample Rd Alexandria

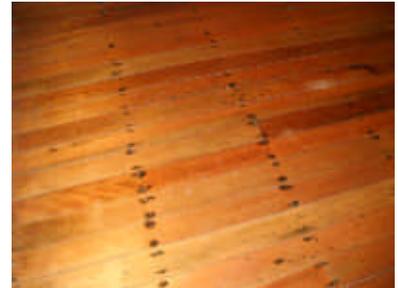
Location/Area: Throughout:

Woodwork: The condition of the woodwork is generally fair. Minor maintenance and or repairs required prior to next repainting.
